Technical Note

Construction of relief wells under artesian flow conditions at dam toes: engineering experiences from Karkheh earth dam, Iran

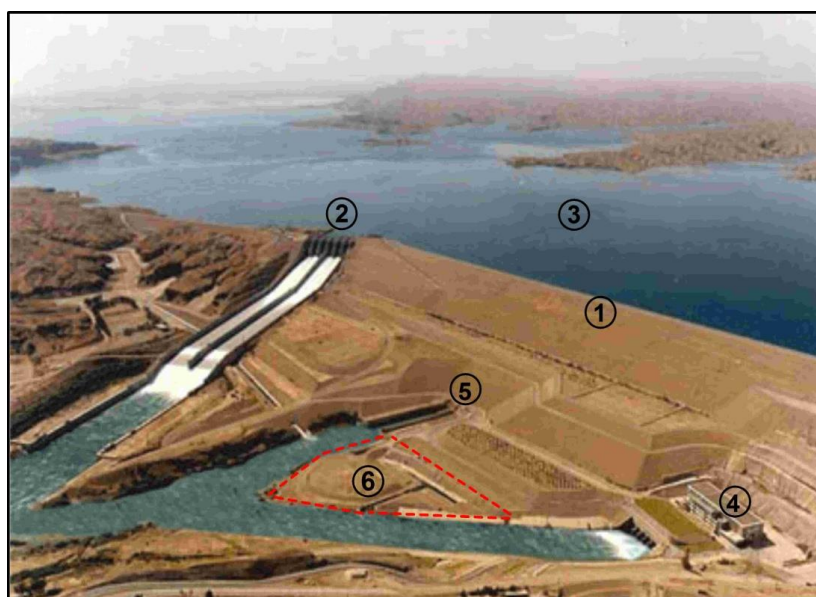
Fig. 1 General plan of the Karkheh dam project. The numbers represent: 1, dam crest; 2, spillway; 3, reservoir; 4, powerhouse; 5, diversion culverts; and 6, the location of the new relief wells at dam toe (the red-dashed polygon)

Karkheh, an earth and rockfill dam with the height and length of 127 and 3030 m respectively, is the largest dam in Iran in view of reservoir capacity (Fig. 1). The capacity of

the Karkheh River, a power house with total capacity of 400 MW at the left abutment and a gate-controlled chute-type spillway (Fig. 1). The Karkheh Dam provides about 4 billion cubic meter of regulated water to irrigate 320,000 hectares of downstream farmlands.

Considering the presence of an artesian aquifer in the foundation of the Karkheh dam and associated probable uplift pressure in the future, some relief wells were constructed in the downstream toe of the dam during its construction (1995-2001) (red-dashed polygon in Fig. 1). These well penetrated from 10 to 20 m into the artesian aquifer with spacing of about 20 m from each other. In total, 19 relief wells with the diameter of 2 or 3 inches were constructed to relieve part of the excess uplift pressure of the artesian aquifer and consequently to improve the safety factor of the area against instability (Mahab Ghodss Engineers 1998 [10]). After the reservoir impoundment in February 2001, these wells discharged water from the confined aquifer and relieved the existing hydrostatic pressure. Due to some shortcomings in the installation of these wells, and improper estimation of the foundation permeability (Mirghasemi and Pakzad 2005 [11]), they were not able to effectively discharge water from the confined aquifer. At the highest reservoir level, the total amount of water discharge from 19 relief wells was about 35 lit/sec which was a disappointing record.

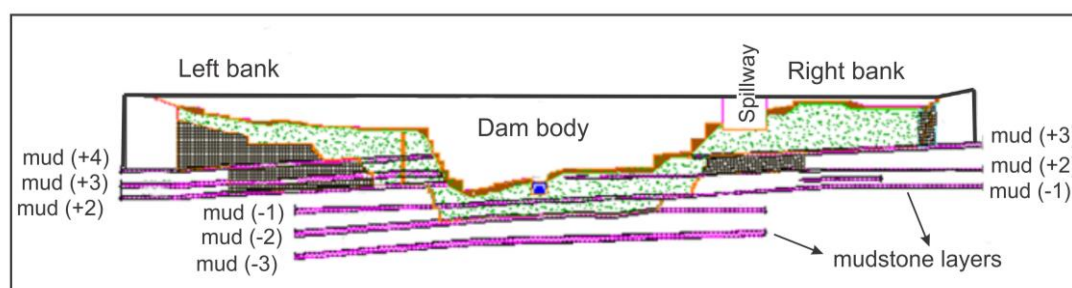
Fig. 2 Karkheh dam longitudinal section showing dam geological layers. Dotted and hatched areas represent the extensions of the dam's old and new plastic-concrete cutoff walls. The figure is exaggerated in the vertical direction

dam is responsible for the establishment of high uplift pressure at the downstream toe of the dam. Karkheh dam is placed on a horizontally-stratified foundation which is a combination of permeable conglomerate and relatively impervious mudstone layers (Fig. 2). The overall permeability of the conglomerate is estimated to be in the relatively high range of about $4-9 \times 10^{-4}$ m/s. The impervious horizontal mudstone layers stratify the conglomerate with 3 to 9 m thickness and a permeability of about 10^{-7} to 10^{-10} m/s, which are bedded horizontally in the area of the project (Fig. 2). In Fig. 2, the mudstone layers are numbered due to the river bed level so that the layers located above and below the river bed level are entitled with plus and minus numbers, respectively.

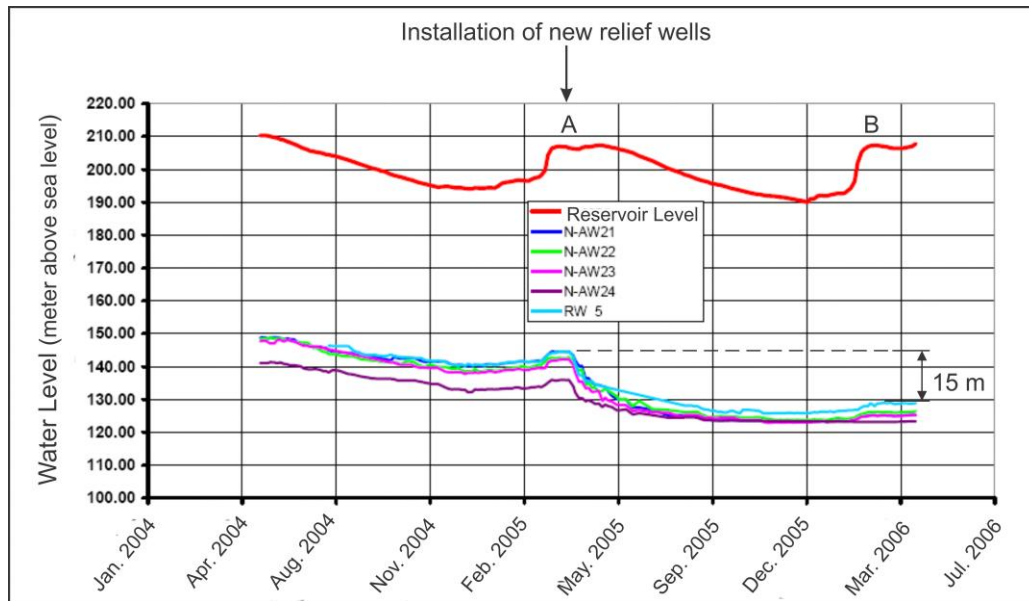
Fig. 3 Water level fluctuations for the conglomerate layer between mudstone layers (-3) and (-2) in some observational wells, installed in the downstream of the Karkheh dam. The thick-red line at the top of the figure shows reservoir water level

To monitor the performance of these relief wells and to determine their precise effect on the reduction of the uplift pressure, some observational wells were installed in the artesian aquifer. Figure 3 presents fluctuations of water level in the conglomerate layer between mud (-3) and mud (-2) at 5 observational wells, installed at the downstream of the dam. These observational wells were installed at the dam toe in the area shown with the red-dashed polygon in Fig. 1. As can be seen, for the reservoir water level of around 200 m (in September 2004, Fig. 3), the water level in the observational wells was around 140 m. Since the elevation of the dam toe is around 120 m, the water levels in the observational wells produce an uplift pressure of around 20 m (i.e., 2 atm) to the dam toe. For the reservoir water level of 210 m (in April 2004, Fig. 3), the hydrostatic pressure to the dam toe is about 30 m above the ground level (Fig. 3). Such high uplift pressures decrease the safety factor of the dam toe to the unsafe value of 0.95 (Mahab Ghodss Engineers 2004 [5]). Therefore, installation of new relief wells was necessary to relieve part of these excessive uplift pressures and to assure the stability of the dam toe.

wells was used (Fig. 3). Based on these observational wells, the water surface was estimated about 15-20 m above the ground surface at different locations in the region shown by dashed-red polygon in Fig. 1. For controlling artesian flow, a 20-inch diameter vertical pipe with a length of 15-20 m was attached to the top of the 20-inch casing (Fig. 5). The artesian water flow was stopped by adding this long vertical pipe to the top of the well. After the artesian water flow was stopped, filter materials were placed and the interface of the mudstone layer (-2) was blocked (Figs. 4-5).

The best way to evaluate the performance of new relief wells in reducing the regional uplift pressure is measurements from downstream observational wells (Fig. 3). As shown by an arrow in Fig. 3, new relief wells started to be installed around March 2005 (point A in Fig. 3) where the water elevation in the observational wells was about 145 m. Reservoir water level was at 208 m above sea level at this time. It is clear that to evaluate the performance of new relief wells, different water elevations in the observational wells should be compared with each other at the same reservoir water level. Around one year after the installation of new relief wells (i.e., February 2006), the reservoir water level reached the same level of 208 m (point B in Fig. 3). It can be seen that at point B, the water elevation in observational wells decreased to the value of 130 m suggesting a 15-m decrease in regional uplift pressure. This shows that the new relief wells were successful in releasing part of the extreme uplift pressures. Table 1 presents the amount of water discharge of each of the newly-installed large-diameter relief wells. The discharge from each newly-installed small-diameter well was around 10 lit/s. From Table 1 and taking into consideration the discharge from small-diameter wells, the total water discharge of the new relief wells is about 900 lit/s. The drainage discharge from all old relief wells (9 wells- Fig. 6) was around 35 lit/s.

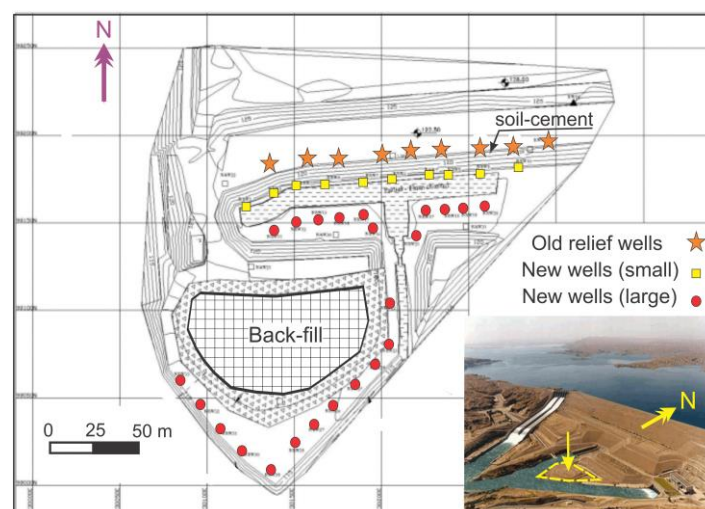
Fig. 6 Location and arrangement of the old and new relief wells installed at the downstream toe of the Karkheh dam

Using this technique, 33 new relief wells were installed at the toe of the dam which are shown in Fig. 6. As shown in Fig. 6, new relief wells are of two types: 10 wells with small diameter and 23 wells with a larger diameter of 6 in. The small-diameter wells are installed at the northern part of the dam toe (Fig. 6) where construction of larger-diameter wells was not possible due to some limitations. In addition to relief well installation, back filling of the dam toe also was considered to increase the safety factor of the area which is shown in Fig. 6.
