Experimental in-plane behavior and retrofitting method of mud-brick walls

F. Tootoonchy, B. Asgarian*, F. Danesh

Abstract

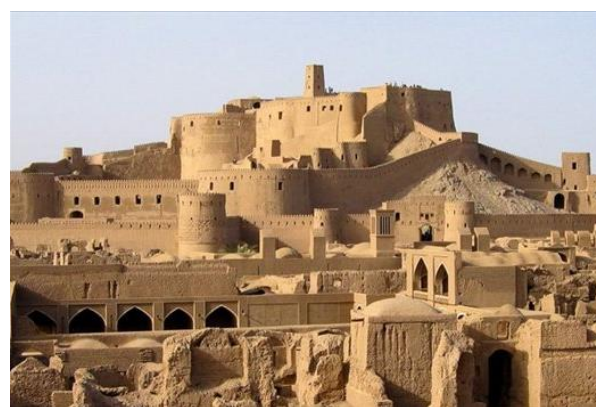
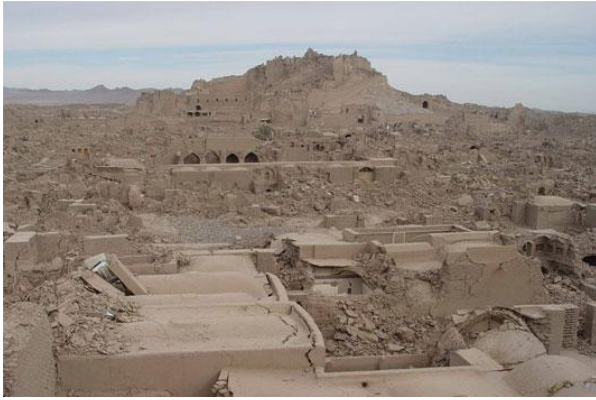
Fig. 2 View of Bam Citadel before and after Bam earthquake

The largest mud-brick structure is the Bam citadel which has been suffered serious damages during 2003 Bam earthquake. During Bam 2003 earthquake, most of the adobe buildings were destroyed, more than 26,000 people were died and over 60,000 were left without shelter [1]. Fig. 2 shows Bam citadel before and after 2003 earthquake.

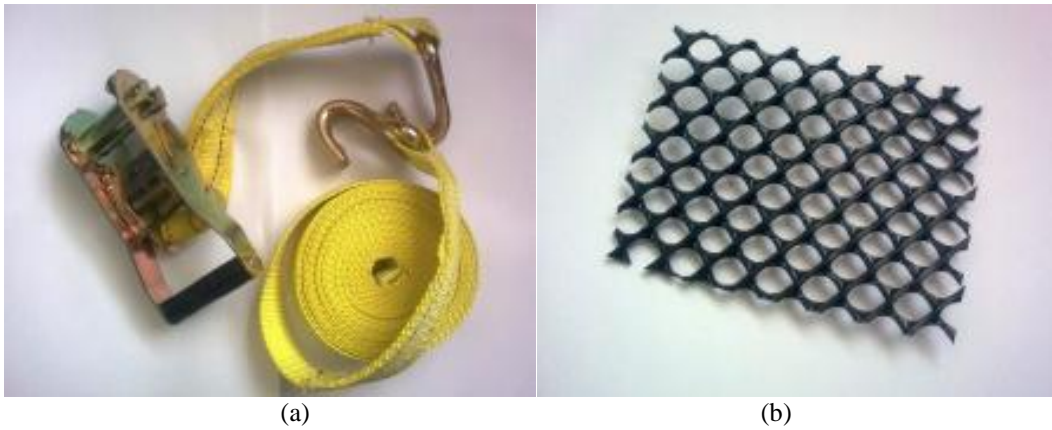
**Fig. 4** (a) Tarpaulin belt, (b) Polypropylene lace

In this regards, some mud-bricks similar to original ones were reproduced from red clay of Abyaneh. Six scaled walls with the dimension of about $1\text{m} \times 1\text{m}$ were constructed by using same red clay mortar. After about one month from the construction time, scaled walls were tested against horizontal loads applied at top of them in the presence of vertical load as shown in Table 1. In the first four samples (MW1 through MW4), the walls were subjected to lateral loads in presence of different amount of vertical stress as shown in Table 1. Meanwhile, no retrofitting was considered for these walls. Tested samples No. 5 and No. 6 (RMW1 & RMW2) had the same dimensions and vertical stress as sample No. 3, but these walls were retrofitted with propylene laces and tarpaulin belts as shown in Fig. 4. Polypropylene laces and tarpaulin belts (with 50 mm wide) were used to improve the performance of these walls (RMW1 and RMW2). Propylene lace which in 10^{mm} mesh (Fig. 4) is strong enough to environmental conditions and has ductile behavior.

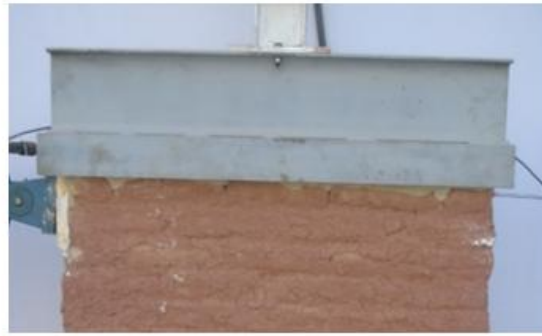
(a) (b)
Fig. 6 (a) Beam section, (b) Load distribution beam

To impose uniform vertical stress on the walls, a hydraulic jack and stiff beam have been used in which stiff beam was directly placed on the wall (Fig. 6 and

distributed uniform pressure during test. For imposing horizontal loads to the walls, hydraulic jack connected directly to the loading frame has been used. To avoid undesirable extra loads, due to top rigid beam movement during experiments, two rollers have been provided in both sides of vertical hydraulic jack, one between vertical jack and loading frame top beam and other between jack and rigid beam as shown in Fig. 7. To measure deformation of the wall, two transducers (LVDTs) were installed on the wall crown and toe.

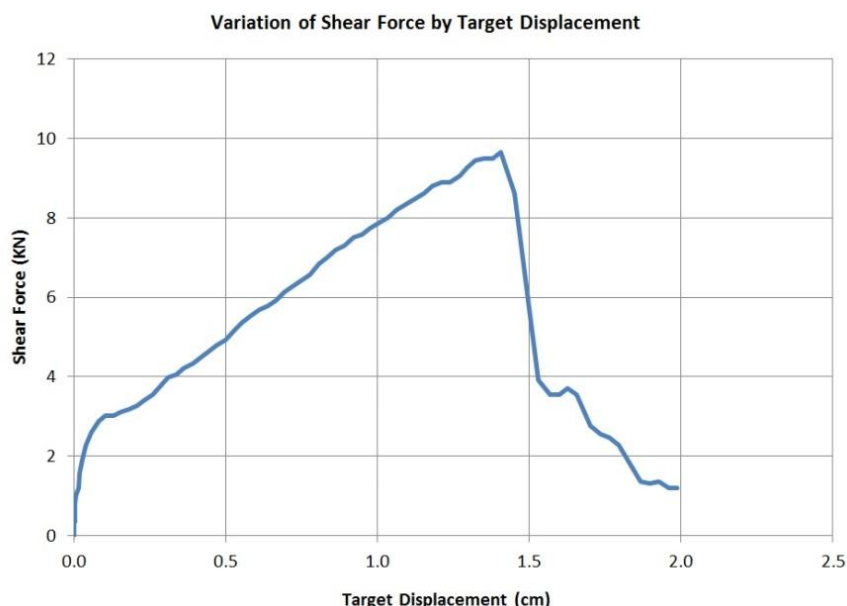
Fig. 10 Curve of shear force against sliding displacement of wall crown MW1

Shear force-lateral displacement curve of MW1 is shown in Fig. 10. Short initial elastic behavior can be observed at the start of the test which was then adjusted by forming a crack in the bed joint. Then, a sudden strength fall was observed during rocking motion mechanism.

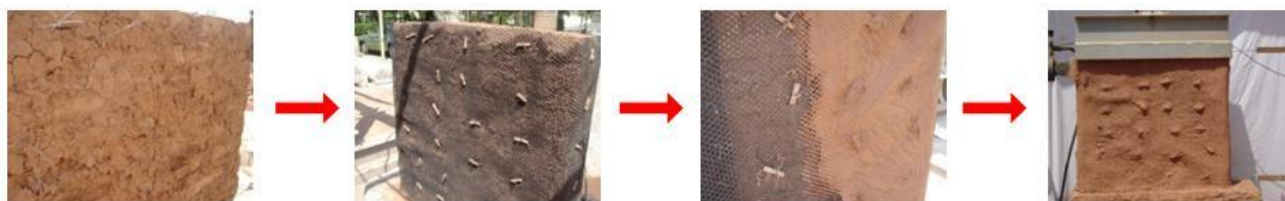
Fig. 14 Installation process of polypropylene lace on adobe walls

behavior and to prevent the wall uplift and rocking motion mechanism was proposed. For this purpose, RMW1 is surrounded only by polypropylene lace. After installing twisted wires in the wall at a distance of about 0.2^{m} , this net is fixed to the wall and then it is filled with clay mortar. The proposed method is a simple and cheap way which can be executed by an un-skilled labor. In the proposed method, when the wall is subjected to lateral loads, a tension force occurs in membrane net of polypropylene lace; by increasing the wall volume, its reaction is imposed on the wall in the form of a pressure confining force. It causes an increase in the shear capacity, ductility and energy absorption of the retrofitted wall compared to original ones. Fig. 14 shows the installation stages of the proposed method. Table 1 also shows the details of a test performed on a reinforced wall with polypropylene lace.

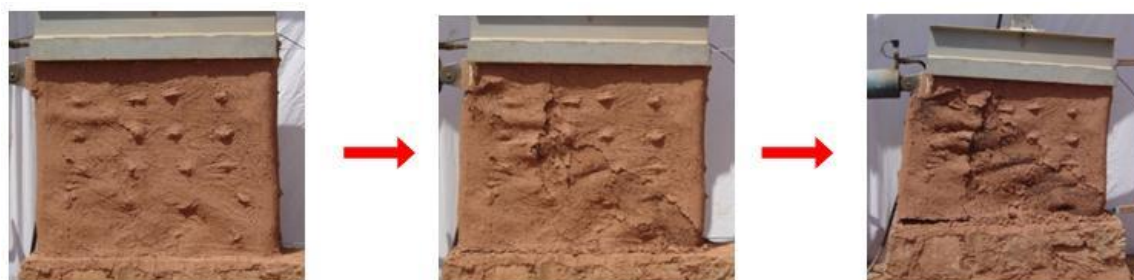
Fig. 15 Damage mechanism of RMW1 wall

To compare the results, a vertical uniform load same as MW3 was applied to retrofitted walls and then the lateral displacement was applied to walls. Fig. 15 shows the views of the RMW1 during the test. It can be seen that the volume of the wall toe was increased during test and the surrounding net was stretched. Then, the volume of the wall was increased around the wall diagonal. Moreover, diagonal cracks were formed without any collapse despite the fact that wall underwent a considerable deformation. Ultimately, rocking motion mechanism was formed following appearance of diagonal cracks. Fig. 16 presents variation of shear force against lateral displacement of RMW1 wall.

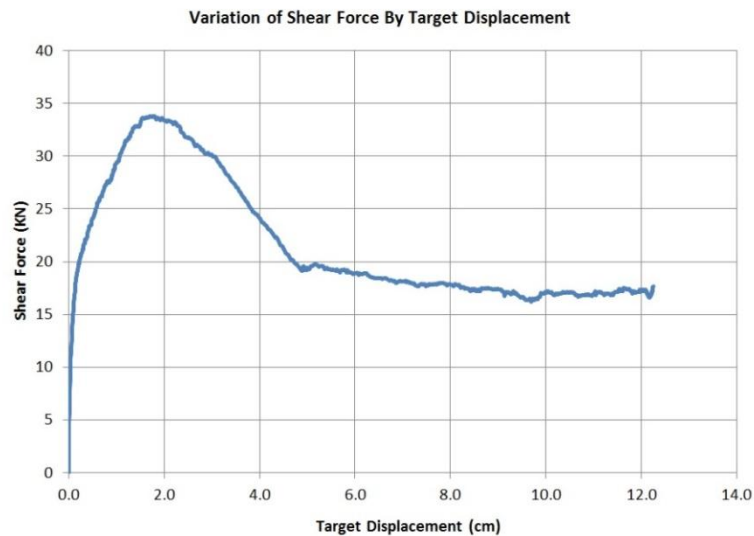
Fig. 16 Experimental behavior of RMW1 wall

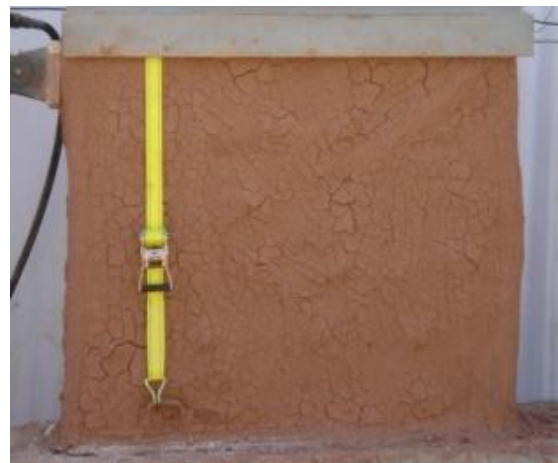
Fig. 17 Use of tarpaulin belts to prevent rocking motion mechanism

It was observed that the application of polypropylene lace caused suitable cohesiveness of the wall compared to the behavior of the similar wall without proposed retrofit method (MW3). It can also be seen that using polypropylene lace resulted proper integrity of the wall. Actually, better performance of the wall was observed by postponing the occurrence of rocking motion mechanism. The sample RMW2 was connected to its foundation by tarpaulin belts (Fig. 17) in addition to using the polypropylene lace same as RMW1 sample. Adding tarpaulin belts helps the wall to postpone or even prevent rocking motion mechanism. Table 1 also shows the details of a test performed on RMW2.

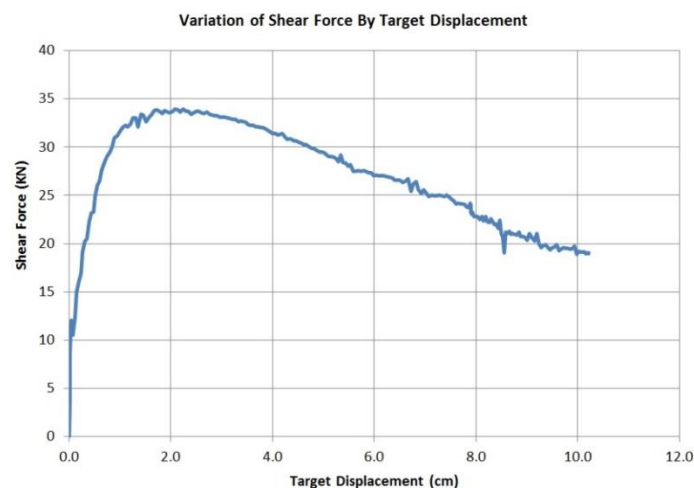
Fig. 19 Experimental behavior of RMW2 wall

Shear force-lateral displacement curve of RMW2 is shown in Fig. 19. Fig. 20 compares shear force-lateral displacement of MW3, RMW1 and RMW2. This Fig.

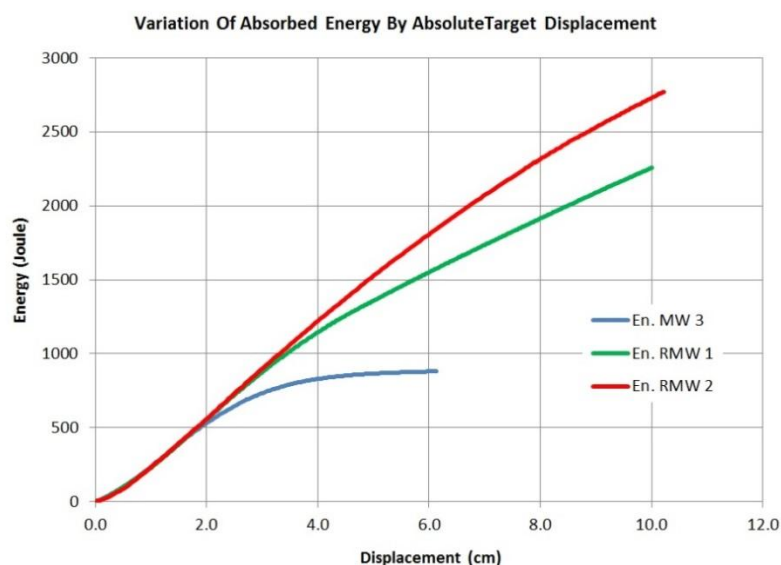
Fig. 22 Energy-displacement curve for retrofitted sample walls compared to non-retrofitted wall

The shear capacity of the wall and its lateral displacement corresponded to 85% of the shear capacity are also shown in Table 2. It can be seen that by retrofitting the wall in addition to increasing shear capacity of the wall, its ductility and energy absorption were increased significantly. The energy deformation curves of the walls without and with proposed retrofitting method are presented in Figs. 21 and 22. It can be seen that the

energy absorption of the walls in large deformation area increased significantly for retrofitted walls. The results for the energy absorption until failure and maximum displacement of the walls are also presented in Table 3. It can be seen that by using proposed retrofitting method, a better performance can be achieved compared to the walls without retrofit.
