Technical Note

Repair effectiveness of CFRP and steel plates in RC beams with web opening: effect of plate thickness

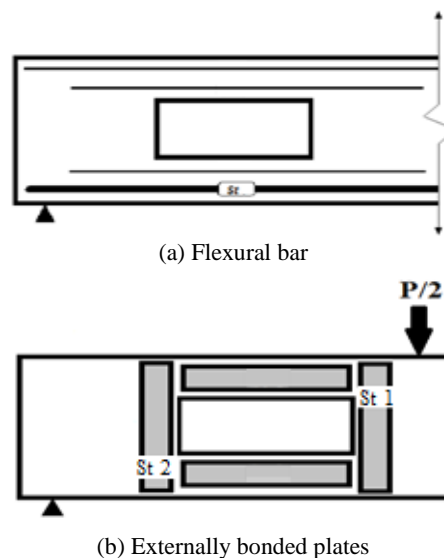
Fig. 2 Locations of strain gauge

The behaviour of load-strain relationship for externally bonded CFRP and steel plates is presented in this section. Strain gauge are fixed at two locations , one locations is on the opening corner near the support (ST2) and another location is at the opening corner near the point of applied load (ST1), as shown in Fig. 2(b). The load against strain curves for beams B1, B2, B3 and B4 are shown in Figs. 7, 8, 9 and 10, respectively. The recorded strains indicate that the value of strain for all beams did not reach the ultimate

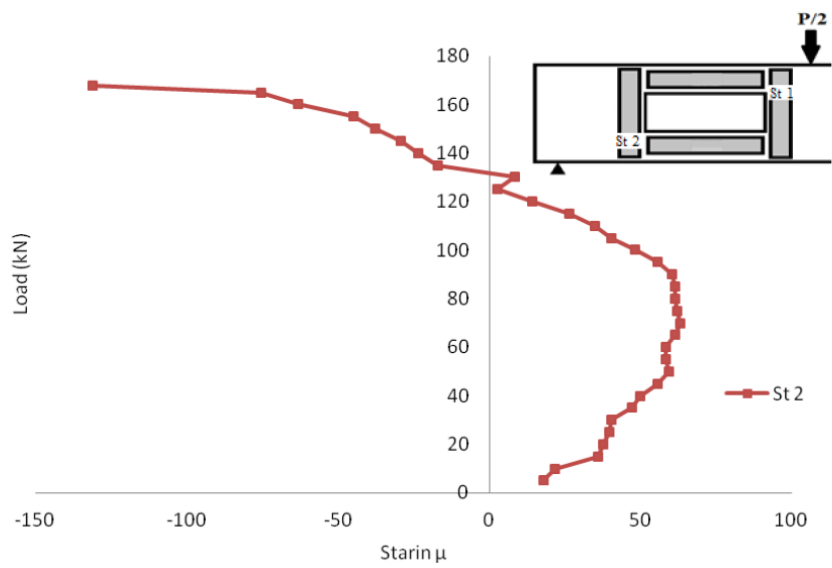
Fig. 8 Load against strain of externally bonded steel plate of beam B2

strain of CFRP and steel plates. This is due to the fact that the concrete failed before allowing the repair materials to reach the ultimate strain values. It can be observed from Figs. 7 to 10 that the externally bonded plates start to share the strain in the beam from the start of the applied load. The results are in agreement with Khalifa and Intomio [20], who found that the maximum CFRP vertical strain measured at failure corresponded to 14 % of the reported CFRP ultimate strain. This value is not absolute, because it greatly depends on the location of the strain gauge with respect to a crack.

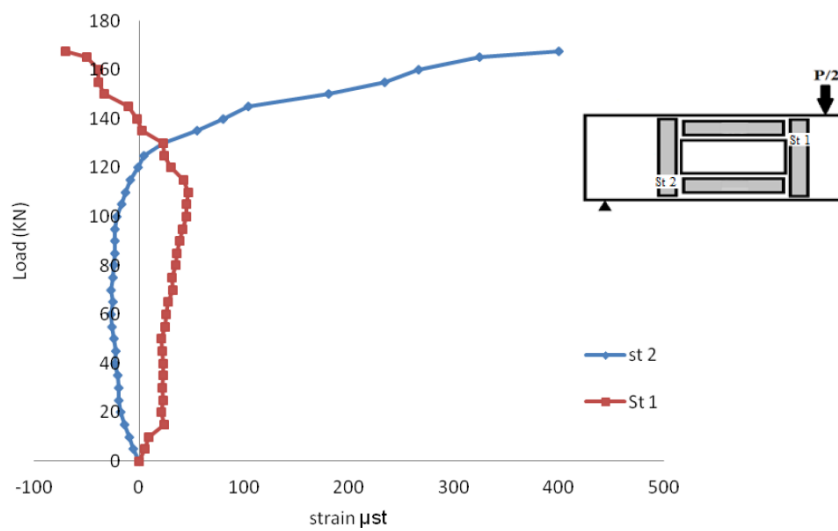
Fig. 9 Load against strain of externally bonded steel plates of beam B3

As can be seen from Fig. 7, for beam B1 the maximum CFRP strain measured at failure was in strain ST1. For beam B3, the steel plate strain measured at failure was deferent at each location, because the value of the strain greatly depends on the location of the strain gauge with respect to a crack, as shown in Fig. 9. It can be observed from Fig. 10 that for beam B4, the maximum CFRP strain measured at failure was in strain ST1, on the bottom chord of the opening. CFRP and steel plates were not fractured or debonded from the concrete surface, and this ultimately indicates that CFRP and steel plates could provide additional strength if the beams did not fail by concrete diagonal shear cracks.

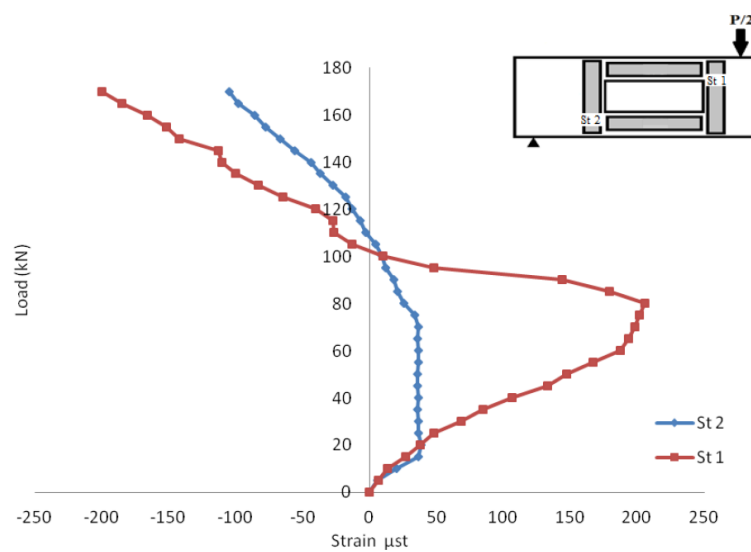
Fig. 10 Load against strain of externally bonded steel plates of beam B4

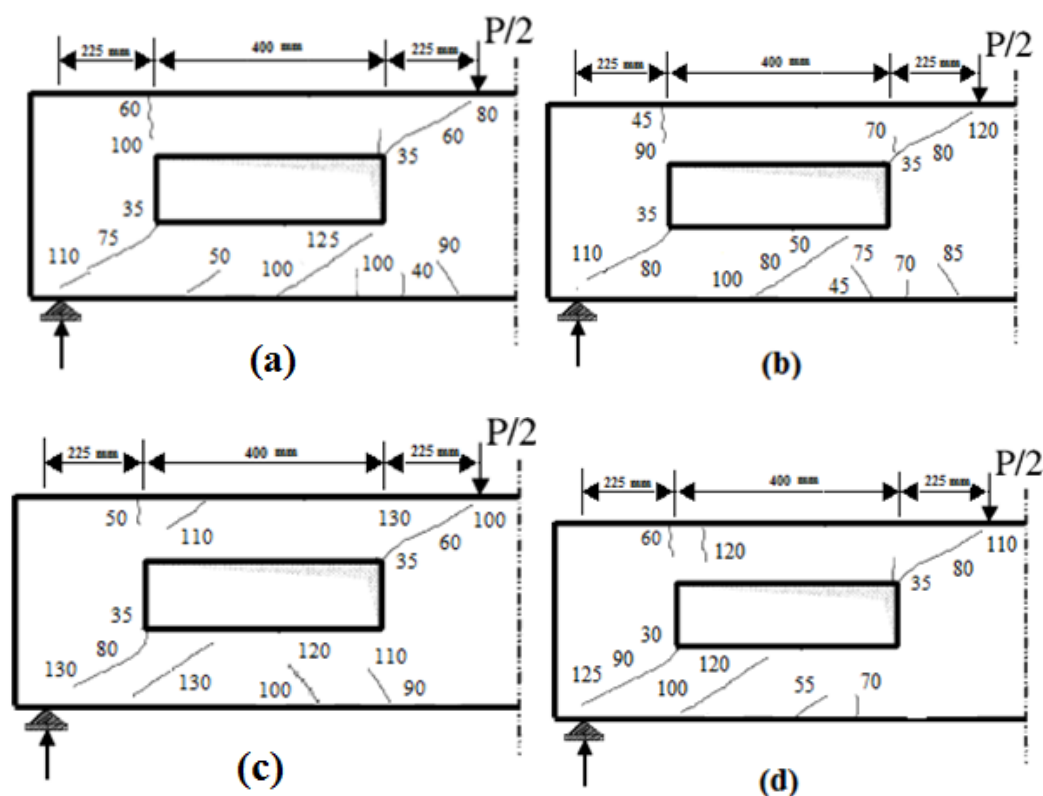
Fig. 11 Crack patterns and failure modes of beams at the pre-repair stage (a) Beam B1, (b) Beam B2, (c) Beam B3, (d) Beam B4

The crack pattern and the failure modes for all beams at pre and post repair stages are presented in this section. Figs. 11 and 12 show the crack pattern and the failure mode for all the beams at the pre and post repair stages, respectively. The failure modes of all the beams are similar because the failure occurs due to failure in concrete as diagonal shear failure before the externally bonded plates reach the ultimate strain. It can be seen from Fig. 11 (b) that the first diagonal crack for beam B2 was observed at the corner of the opening at a load of 35 kN; additional cracks were formed with the increase of the applied load. Failure of the beam occurred when the total applied load reached 128 kN. At the post-repair stage, many cracks were formed at the solid span of the beam, and the failure of the beam occurred at a load of 163.4 kN. At failure, concrete diagonal shear failure was observed around the
