Experimental in-plane behavior and retrofitting method of mud-brick walls

F. Tootoonchy, B. Asgarian*, F. Danesh

Abstract

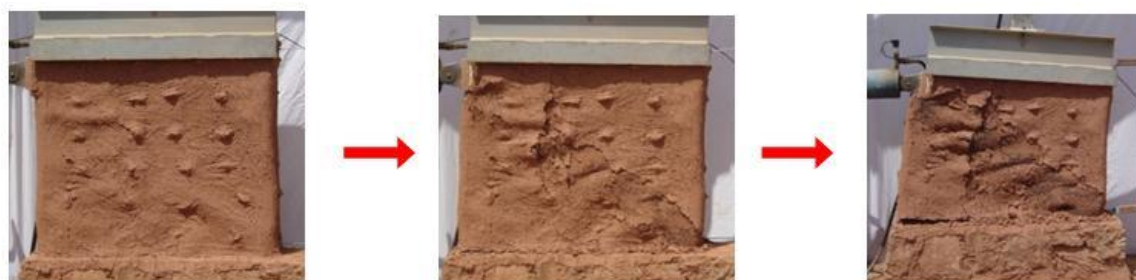
Fig. 15 Damage mechanism of RMW1 wall

To compare the results, a vertical uniform load same as MW3 was applied to retrofitted walls and then the lateral displacement was applied to walls. Fig. 15 shows the views of the RMW1 during the test. It can be seen that the volume of the wall toe was increased during test and the surrounding net was stretched. Then, the volume of the wall was increased around the wall diagonal. Moreover, diagonal cracks were formed without any collapse despite the fact that wall underwent a considerable deformation. Ultimately, rocking motion mechanism was formed following appearance of diagonal cracks. Fig. 16 presents variation of shear force against lateral displacement of RMW1 wall.
