Investigation of long term coupled effect of high temperature and constant high humidity on corrosion rehabilitated patches of reinforced concrete structures

M. Wasim¹, Raja Rizwan Hussain^{2,*}, M. A. Baloch³ Received: August 2013, Accepted: December 2013

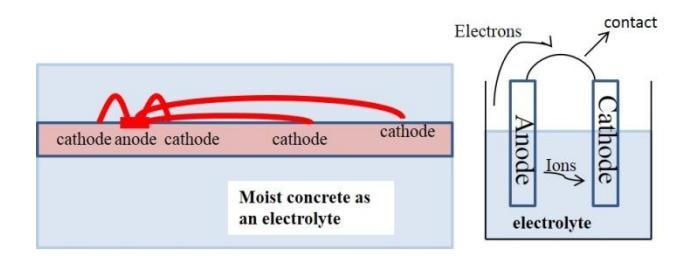
Figure 1 Separation of cathode and anode

The authors of this research paper, previously investigated and established the phenomenon of macrocell formation in the repaired reinforced concrete patches due to the separation of anode and cathode [9], which is illustrated in Fig. 1. They also corroborated that the presence of high chloride content aided by the severe environmental conditions i.e. varying temperature and high constant humidity, not only break the passive film which protects steel from further corrosion but also accelerate the corrosion of reinforcement steel bars even in repaired reinforced concrete patches [10]. However, what would be the effect of long term coupled effect of varying temperature and constant high humidity on macro-cell corrosion of such repaired RC patches remained a question and leads to the objectives of this research paper.

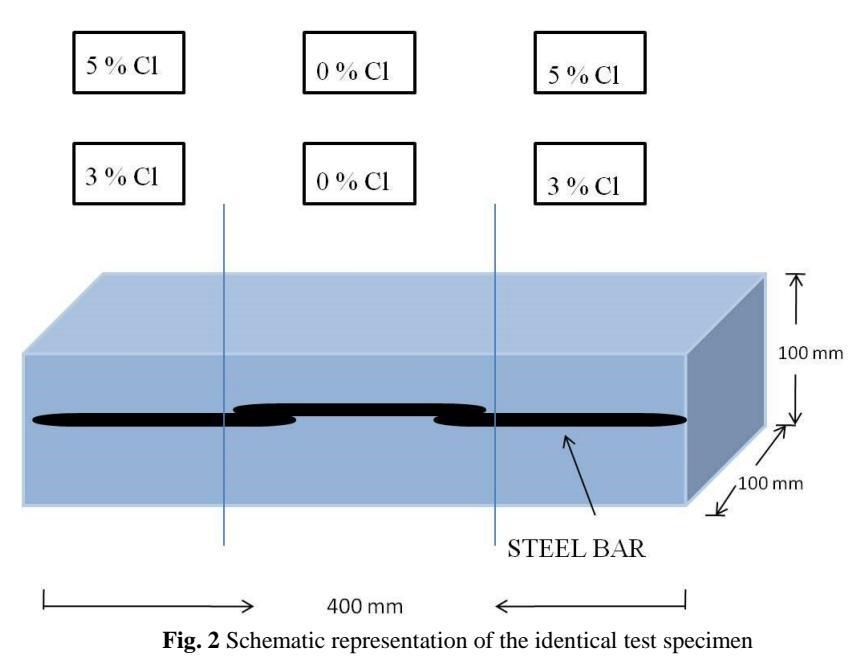
Mould with a separator for middle and end portions

Casting of the end portions in two layers without vibration

After casting in two layers

Fresh middle portion with already hardened end portions

Specimen with completely hardened middle and end portions

This experimental investigation is an extension of the previous research finding [10] in which specimens were prepared for finding the effect of varying temperature and constant high humidity on the repaired corroded patches of reinforced concrete structures. The details of experimentation methodology including preparation of concrete specimens and curing conditions can be found elsewhere [10]. The schematic diagram of these specimens is shown in Fig. 2 and the complete mixing procedure is shown in Fig. 3. Since the objective of this research is to find the long term coupled effect of varying temperature and high humidity on macro-cell corrosion phenomenon, these specimens were kept at 50°C, 40°C and 30°C temperature conditions and 85% relative humidity in environment control chambers for 2 years.

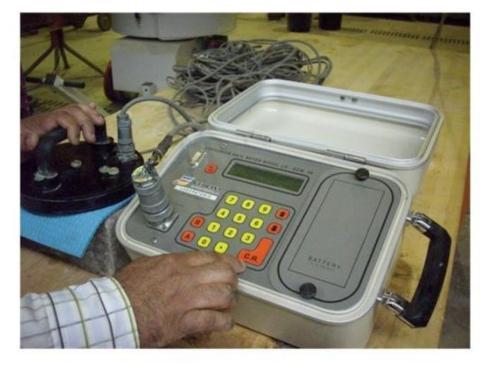
Figure 4 GECORE -8 (Corrosion Measurement device)

The steel rebar corrosion current (Icorr) and corrosion potential (Ecorr) were measured for all specimens using a GECOR device [11] and ASTM C-876 [12]. The GECOR measures the corrosion rate as reflected by the corrosion current density and the half-cell corrosion potential. A true measure of the corrosion rate is possible by the polarization resistance technique. It has been well established by Stern and Geary that the corrosion current is linearly related to the polarization resistance, which gives a direct quantitative measurement of the amount of steel turning into oxide at the time of measurement. By Faraday's equation, this can be extrapolated to direct metal sectional loss. The corrosion current values in GECOR (GECOR-8, 2012) are calculated from the polarization resistance Rp using the relation Icorr = B/Rp, where Icorr is given in $\mu A/cm^2$ when Rp is given in $k\Omega/cm^2$ and B = 26 mV. The Icorr is directly proportional to corrosion rate through the relation, corrosion rate (μ m/year) = 11.6 x Icorr. This gives a tool for quantifying the average reduction of rebar diameter over time. The measurement of corrosion rate usually involves applying electrical signal through a connection to the steel bar. In GECOR this signal is confined to the steel rebar in a circle with a diameter of 110 mm. There is evidence that this technique gives a more accurate measurement of the corrosion rate [13]. The GECOR device is quite valuable and versatile for the corrosion measurement of steel in concrete. See Fig. 4 for further illustration.

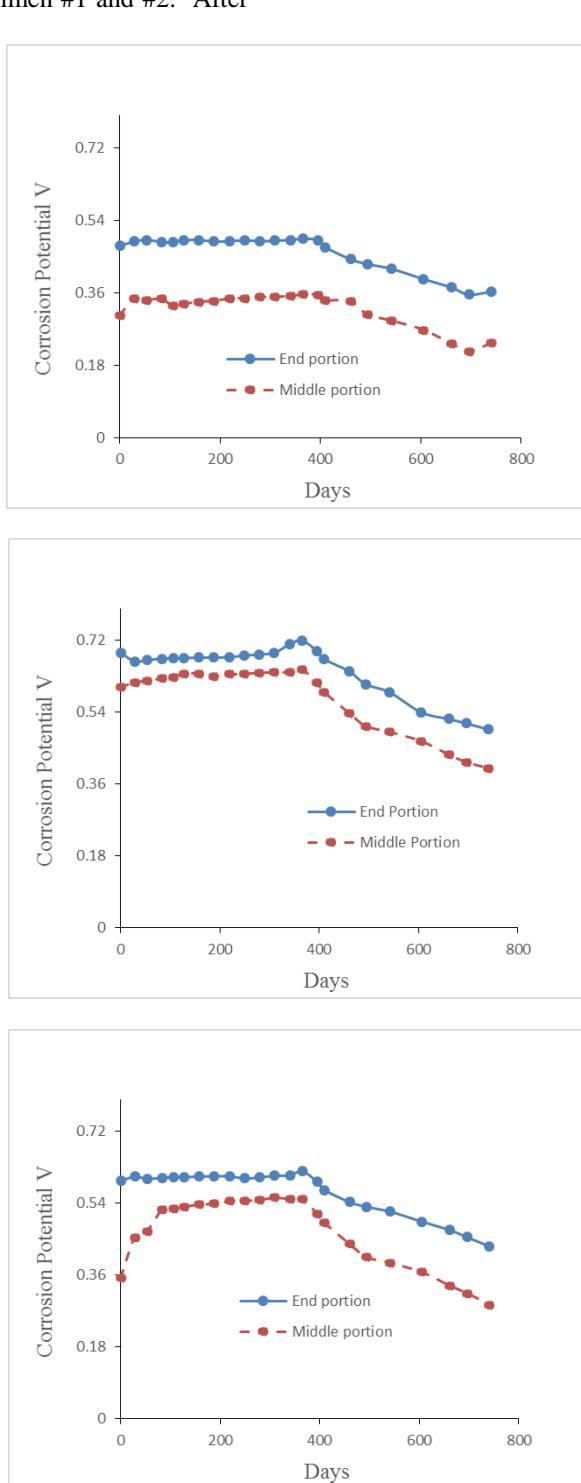
Fig. 5 (a-c) Corrosion potential measurement for 5% contaminated chloride specimen at the end kept at 30°C, 40°C and 50°C

1) At the middle non contaminated portion of the specimen having 5% chloride at the end portions and kept at 50°C (#1 and #2), the maximum corrosion of **-0.235** Volts was found after 2 years as compared to **-0.285** Volts at 30°C in the middle zero chloride portion of the same specimens (#5 and #6). However previously, much higher readings of these specimens were obtained on completion of one year observations [10]. The reason of this phenomenon could be the long term coupled effect of temperature and constant high humidity due to which the decline in corrosion potential after two years was significant. The results are shown in Figs. 5 and 6.

2) The maximum corrosion potential reading of the specimens #1 and #2 was found **-0.363** Volts as compared to high chloride induced potentials of **-0.432** Volts (figure 5) of the same specimens #5 and #6 at 30°C (figure 4)

3) At the middle non contaminated portion of the specimen #3 and #4 which were put at 40 $^{\circ}$ C maximum corrosion potential of **-0.399** Volts was found, being higher than the other specimens at 30 and 50 $^{\circ}$ C.

4) The highest corrosion potential of **-0.497** Volts was found in specimens #3 and #4 as compared to **-0.363** Volts at the two extreme ends of the specimen #1 and #2. After

365 days of observations, significant decline was observed that potential dropped from -.702 to -0.497 after one more year of observations.

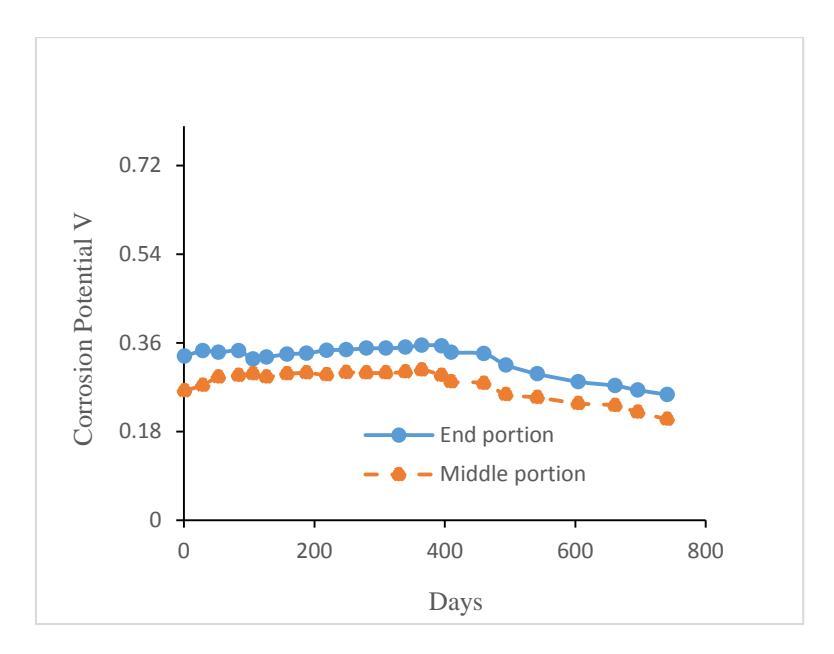
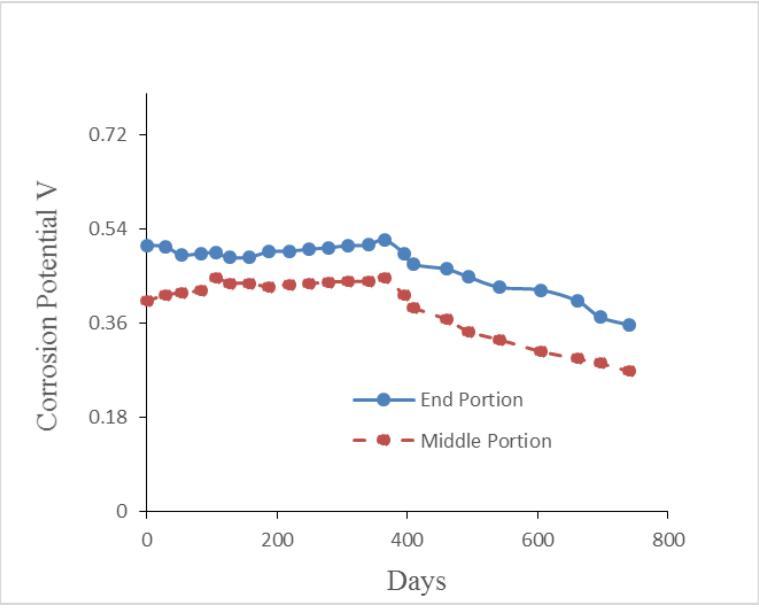
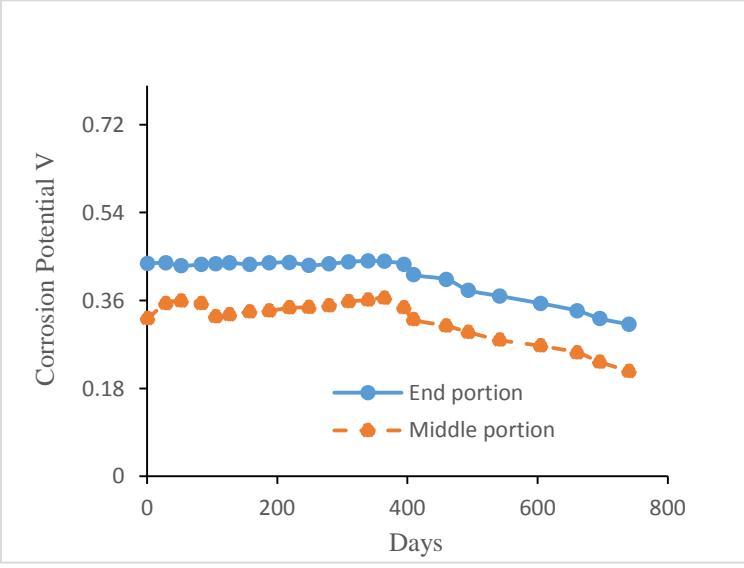
Fig. 6 (a-c) Corrosion potential measurement for 3% chloride contaminated specimen at the end kept at 30°C, 40°C and 50°C

5) In the 3 % chloride contaminated specimens (#7 and #8) at the end, the corrosion potential of -0.255 Volts was obtained as compared to high -0.311 Volts of same specimens (#11 and #12) which were kept at 30 $^{\circ}C^{\circ}$.

6) In specimen #7 and #8, the corrosion potential of - **0.205** volts at the middle non contaminated portion was obtained as compared to -**0.215** Volt at 30°C.

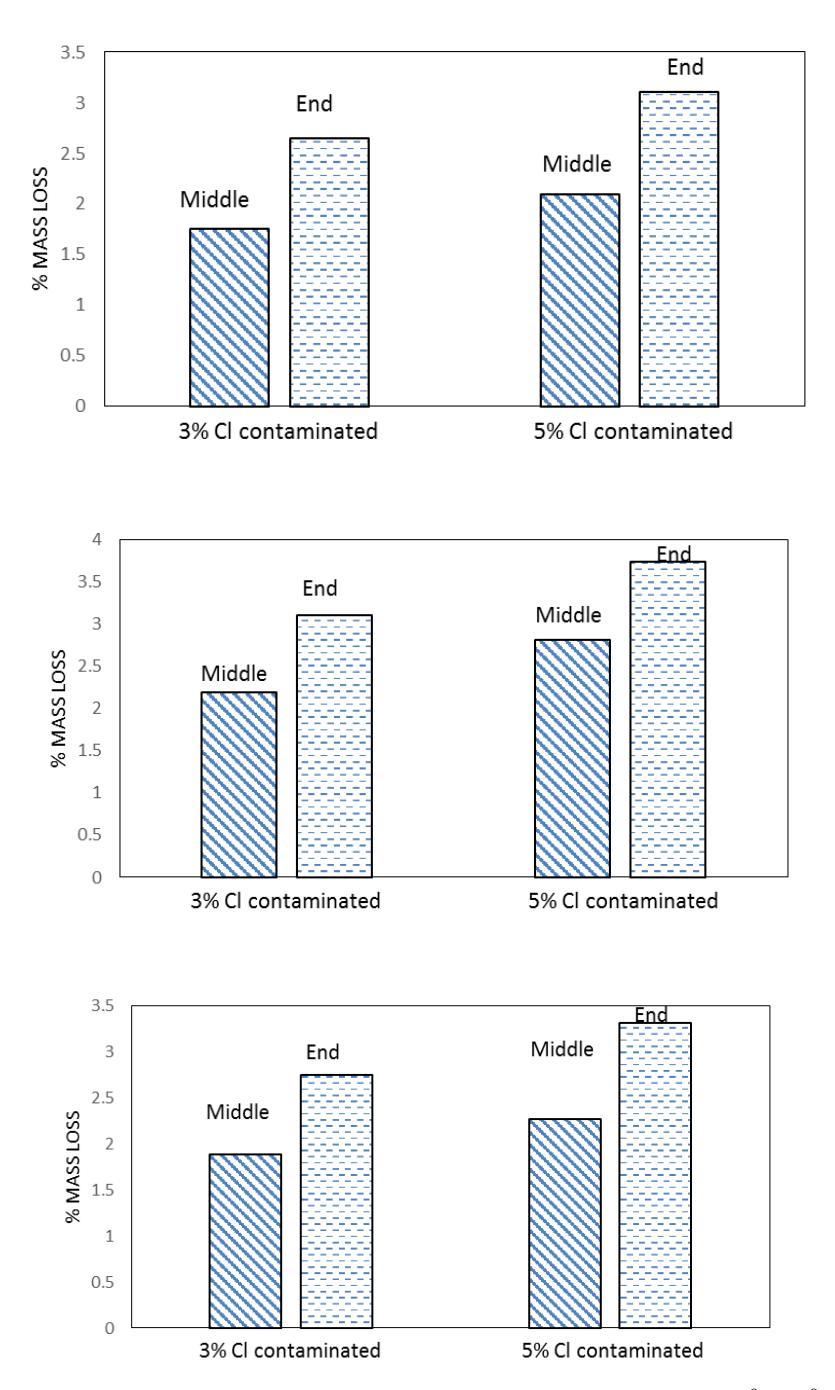
Fig. 7 % Mass loss for 3% and 5% chloride contaminated specimen at the end kept at 30°C, 40°C and 50°C

1) The steel bar from the end portion of 5% chloride contaminated concrete gave the highest % mass loss of 3.73 at 40°C while the steel bar from its middle portion gave 2.81 % mass loss. When the steel taken from the end portion of the same specimen kept at 30°C gave the highest % mass loss of 3.11 and 2.09 % obtained from its middle steel. However interestingly even after exposure of two years observation, the

steel of the end portion of the same specimen kept at 50°C gave the highest % mass loss of 3.31 and middle steel gave 2.27 % mass losses which was lower than the mass losses at 40°C. The results are shown in Fig. 7.

2) The steel from the end portions of 3 % chloride contaminated concrete specimens kept at 30°C, 40°C and 50°C gave 2.65, 3.11 and 2.75 % mass loss respectively. While the middle steels from the uncontaminated portion of these specimens gave 1.75, 2.19 and 1.88 % mass losses respectively as shown in figure 7. Similarly in the 3% chloride contaminated specimens reduced % mass losses at 50°C obtained as compared to the mass loss at 40°C, confirming the authenticity of the results of this research.

As it can be seen from gravimetric mass loss results of various specimens put in varying temperatures, shown in figure 7(a-c), the steels from the middle portion of all the specimens simulating the actual patch repair in field, were corroded and gave approximately 70% of the mass loss obtained in their respective contaminated end portions, indicating the chloride transfer and vulnerability of repaired portion against corrosion.
