AN INVESTIGATION ON EFFECT OF BOND COAT REPLACEMENT ON HOT CORROSION PROPERTIES OF THERMAL BARRIER COATINGS

Abstract: In the present study NiCrAlY bond coating layer was produced by electroplating against common atmospheric plasma spraying (APS). Both types of the bond coats were applied on IN738LC base metal then, the YSZ (ZrO_2 -8% Y_2O_3) thermal barrier top layer was coated by atmospheric plasma spray technique. Hot corrosion is one of the main destructive factors in thermal barrier coatings (TBCs) which come as a result of molten salt effect on the coating-gas interface. In this investigation the hot corrosion behavior of coatings was tested in the furnace which was contain Na_2SO_4 -55% V_2O_5 and mixed salts environment at 900°C up to 15 hr. dwell time. Optical microscopy, scanning electron microscopy (SEM / EDS) and X-ray diffraction analysis (XRD) was used to determine the crystallographic structure and phase transformation of the coatings before and after the hot corrosion tests. The transformation of tetragonal Zirconia to monoclinic ZrO_2 and formation of YVO_4 crystals as hot corrosion products caused the degradation of mentioned TBCs. The results showed NiCrAlY coate

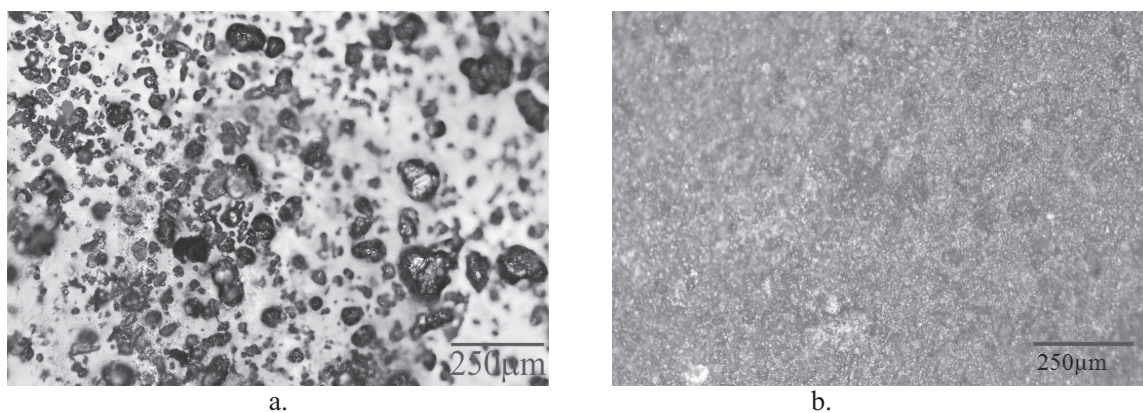
Fig. 2. Optical microscope image of NiCrAlY coating surface, (a) Before heat thermal, (b) After heat thermal

Figure 2 Optical microscope images from surface of the electroplated NiCrAlY before and after heat treatment. Energy dispersive X-ray

bond coat. Therefore, Heat treatment makes a completely homogenization and diffusion of the coated elements to gather because of reducing holes, surface roughness and uniform distribution

of elements after the heat treatment cycle. So the heat treatment makes a good uniformity in the structure and alloying of the coating.

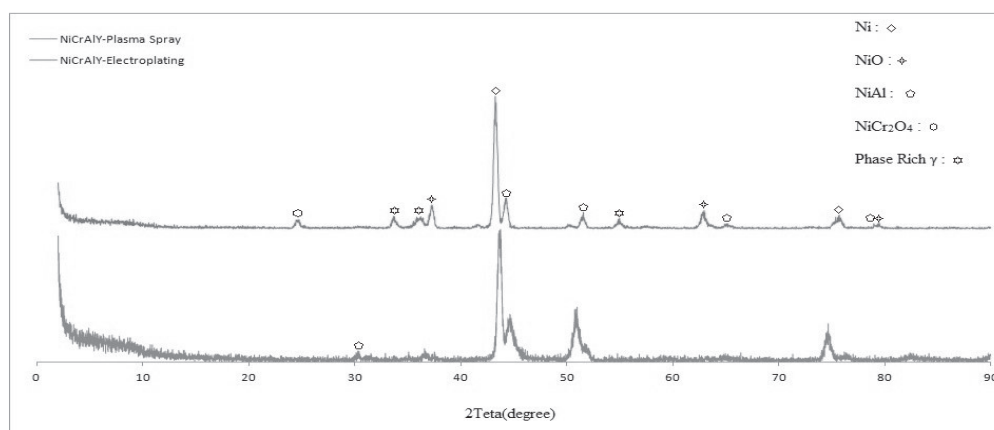
Fig. 4. X-ray diffraction analysis of the coverage of the bond coat after 2 h of heat & of the coating by plasma spraying

X-ray diffractions of bond coats were presented in Figure 4. It can be seen, the main phases in the both of coatings is Ni, NiO and β -NiAl. Electro plated bond coat also contain many small amount of NiCr_2O_4 and metallic yttrium

phases. Presence of oxides like NiO and NiCr_2O_4 in the electro co-deposited NiCrAlY may due to low levels of oxygen, which exist in the heat treatment and Yttrium doping process atmospheres.

sufficiently high, the β phase percolates and contains a dispersion of γ -Ni particles. Such a structure is certainly less favorable in terms of ductility. If the aluminum content is not too high, nickel and cobalt base alloys consist basically of a ductile γ solid solution (face centered cubic) containing a dispersion of β -NiAl or β -CoAl phase [1]. For avoid of presence of brittle mortal γ -Ni and γ' -Ni₃Al phases, balance level of Al powders with optimum heat treatment parameters was selected. Absence of these phases were proofed by X-ray diffraction pattern (Fig.4)

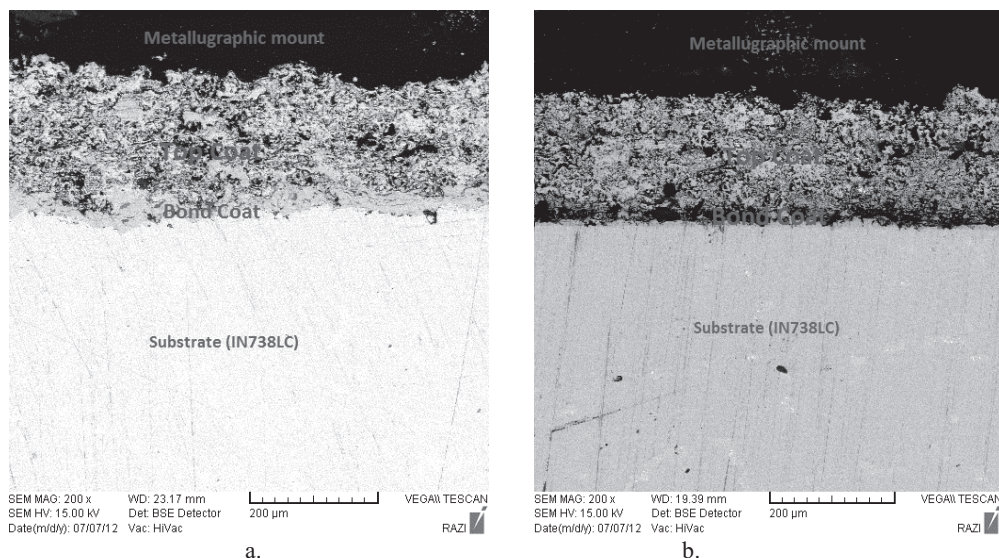
Fig. 5. Scanning electron microscope image, (a) Cross section of the bond coat of the plasma spray coated, (b) Cross section of the bond coat is coated with electrochemical method.

After completing researches on bond coat layers, both of samples coated by air plasma spray YSZ as top coat of TBCs. Fig. 5 shows the cross-sections of the two types of TBCs. In Fig. 5a, usual thermally sprayed TBC is observed which includes NiCrAlY bond coat and YSZ layers. In Fig. 5b, changes TBC are observed which includes electroplated NiCrAlY bond coat and thermally sprayed YSZ layers. Both of the coatings showed the lamellar structure on the top coat which is a characteristic of plasma sprayed coatings.

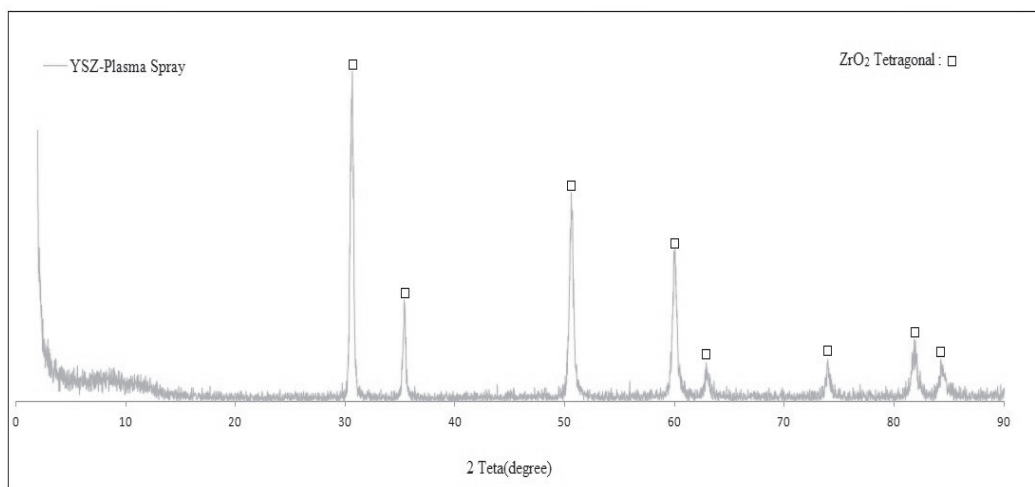
Fig. 6. XRD patterns from the surface of the Top coat before hot corrosion test.

Surface morphology and X-ray diffraction pattern of final coats were presented in Figure 6. These figures shows a Lamellar as spray ceramic structure which flattened splats without melting because of high temperature melting point of YSZ. Completely crystalline tetragonal Zirconia was produced during the thermal spray without any phase transformation to amorphous phases.

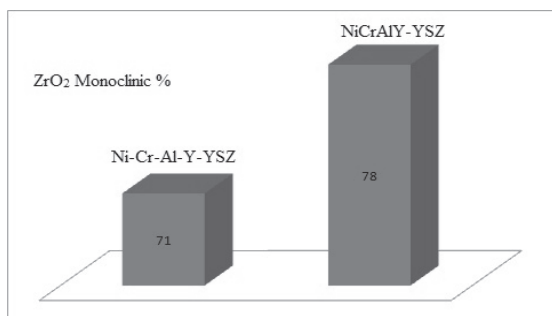
Fig. 10. Volume fraction of monoclinic zirconia in the coatings after hot corrosion test.

Where T is the intensity of tetragonal ZrO_2 (1 0 1) peak, M (1) the intensity of monoclinic ZrO_2 ($\bar{1}$ 1 1) peak and M (2) is the intensity of monoclinic ZrO_2 (1 1 1) peak in XRD patterns after hot corrosion tests [6]. The quantities of destabilized Zirconia phase (M %) have been compared in Fig. 10 which shows the monoclinic ZrO_2 fraction decreased from 71% in (NiCrAlY electroplating +YSZ plasma spray) to 78% in conventional TBC.

This means that transformation of Zirconia from tetragonal to monoclinic phase during cooling was much lower in (NiCrAlY electroplating +YSZ plasma spray). This is better
